IICL - TB 016, January 11, 2019

Title: Roof measurement of outwards deformations.

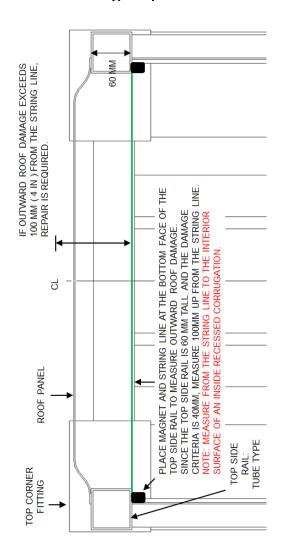
Page 67

- On tube type top rails, if the damage measured from the lower face of the top side rail to the roof panel recessed corrugation exceeds 100 mm (4 in), repair is required.
- On flat bar type top side rails, if the damage measured from the lower face of the top side rail to the roof panel recessed corrugation exceeds 55 mm (2-9/16 in), repair is required.

Measuring Outward Roof Damage Criterion
Tube Type Top Side Rail

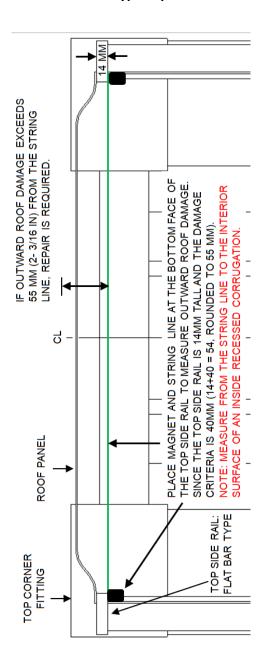
Page 71

Measuring Outward Roof Damage Criterion
Flat Bar Type Top Side Rail
