September 25th, 2020

IICL Technical Bulletin - TB-023 - rev 1 / 23 Oct 2020

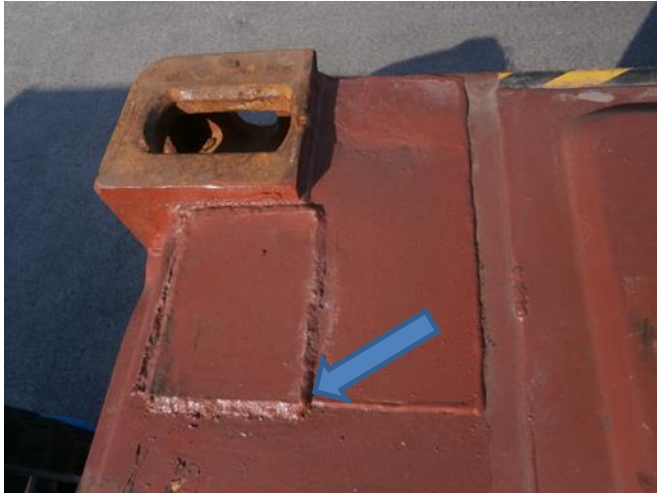
Non-conforming patch exceeds the original size of the Corner Protection Plate.

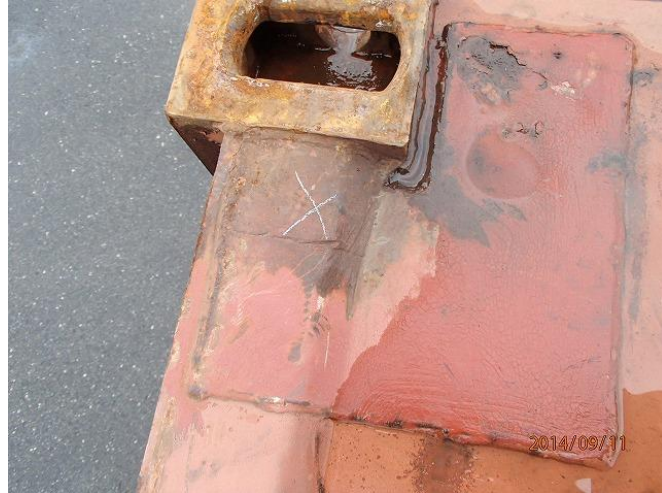
Acceptable insert on corner protection plate. Any damage to the front header must have been repaired prior to insert installation. Repair shall not protrude above the upper face of the corner fitting.

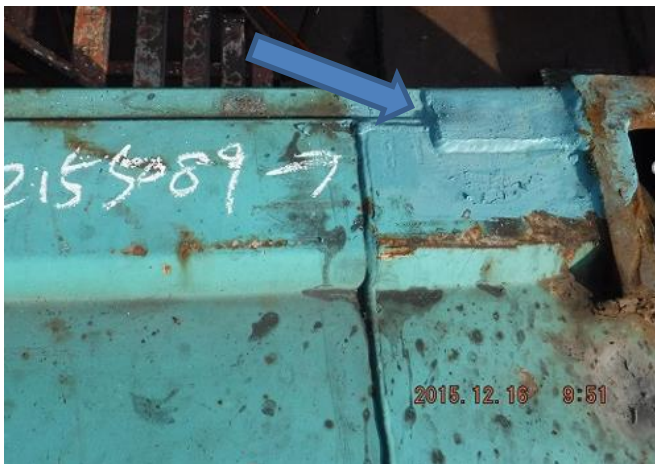
Non-conforming patch to the corner protection plate, overlaps the front header.

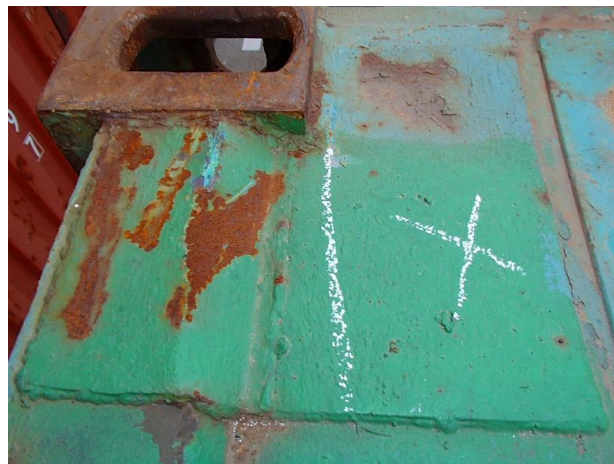
Acceptable insert on corner protection plate. Any damage to the header must have been repaired prior to insert installation.

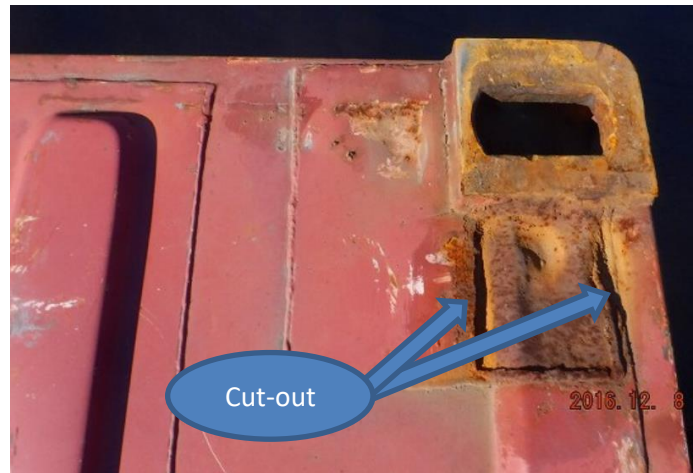
Non-conforming repair.

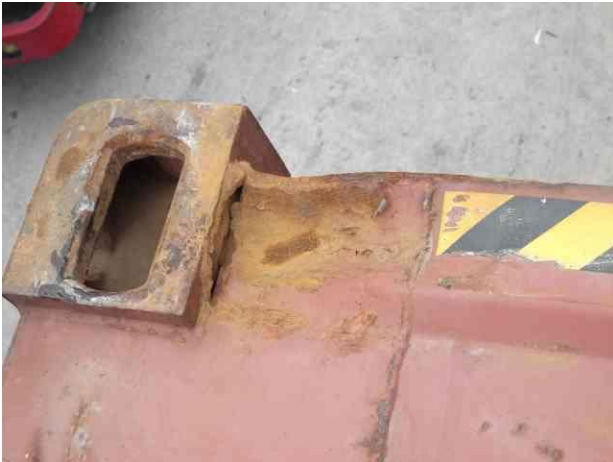
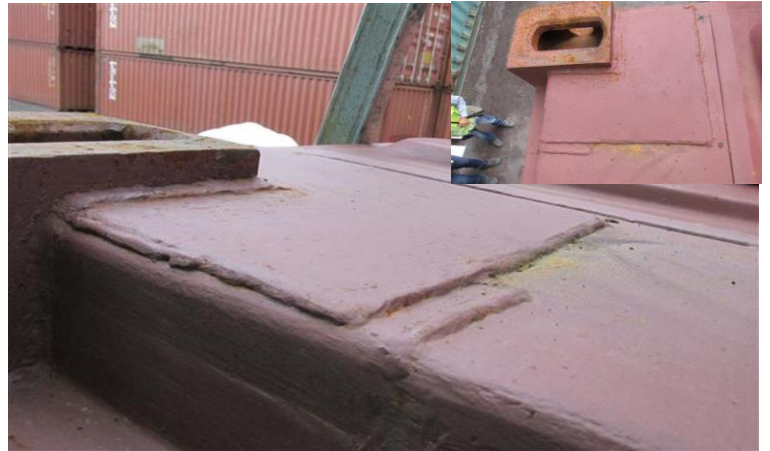
Proper replacement of the corner protection plate after installation of insert on the front header.

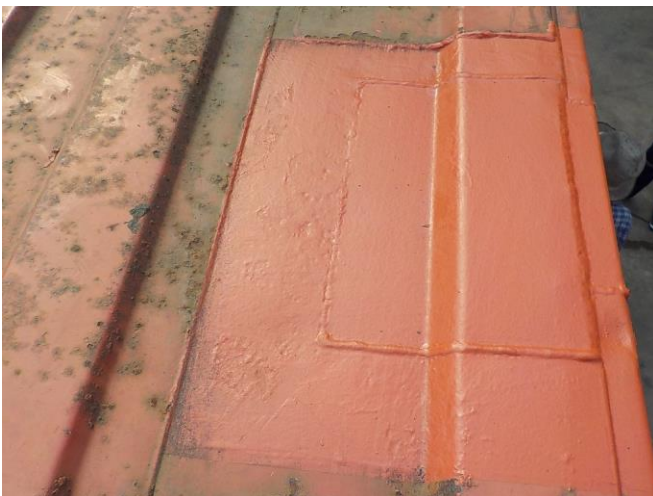
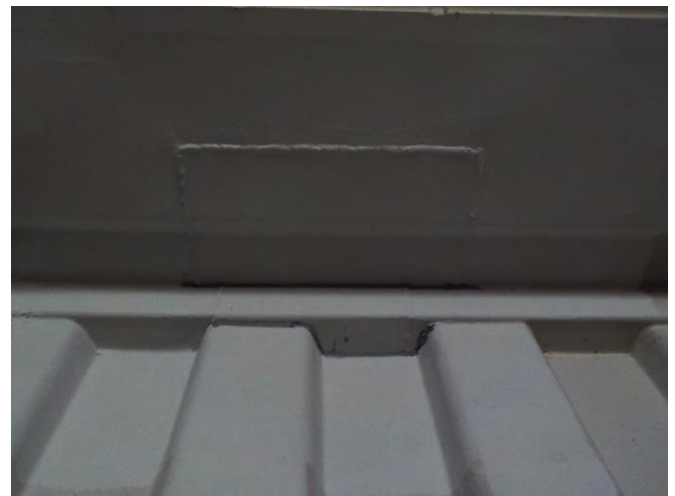
Proper insert to the header extension plate.

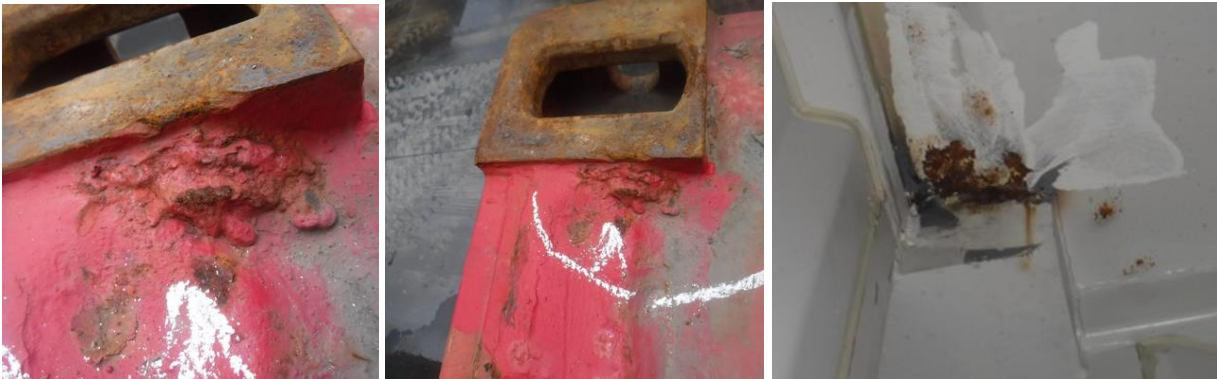
Non-conforming repair. Damaged area filled with weld without restoring original profile of the rear header and corner protection plate.

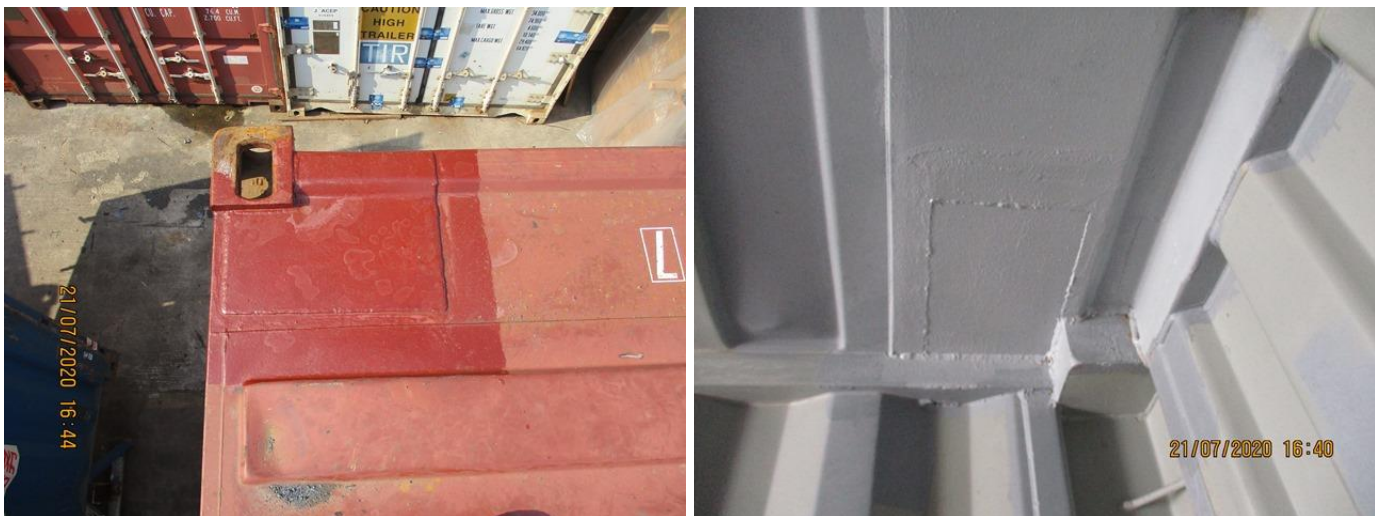
Proper replacement of the corner protection plate after installation of insert on the extension plate.

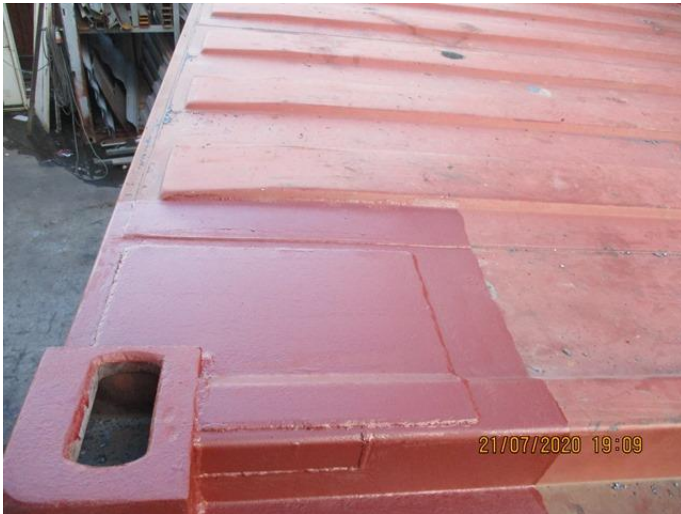
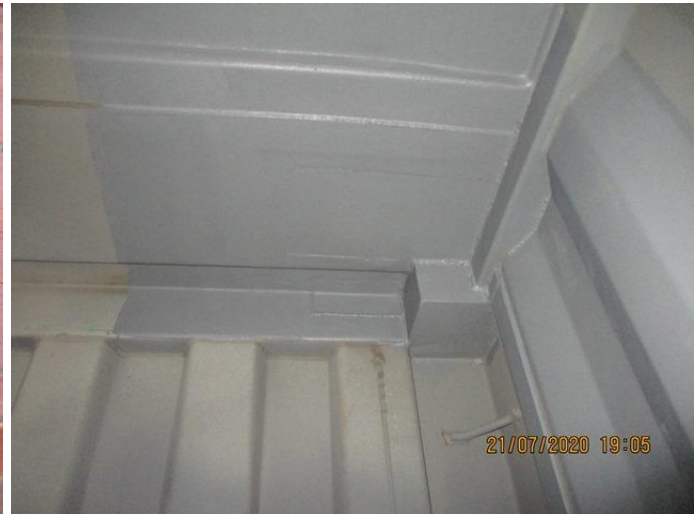
Proper replacement of the corner protection plate after installation of insert on the front header.

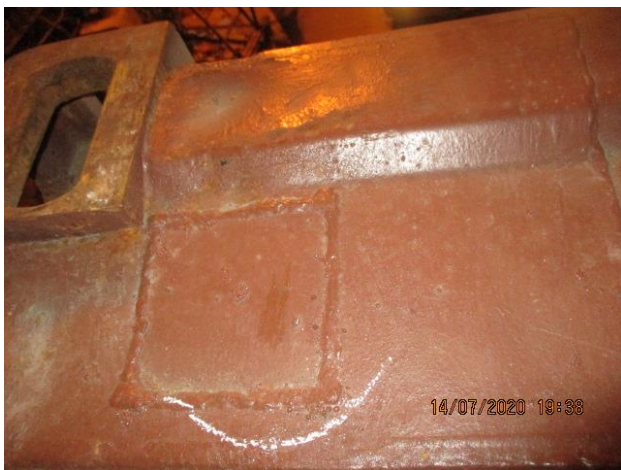
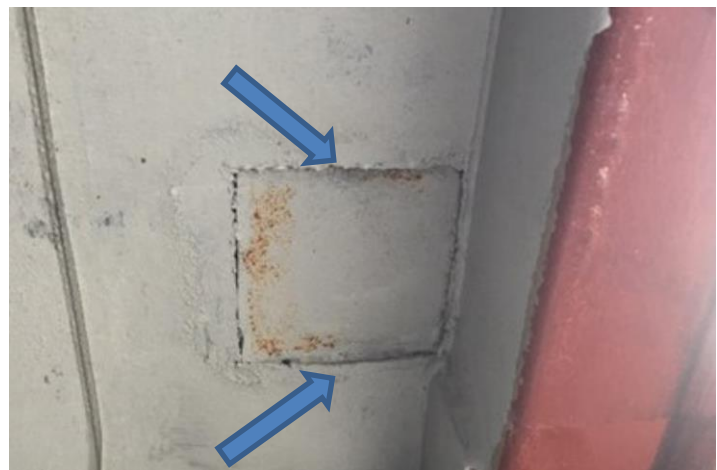
Non-conforming repair: insert installed on the corner protection plate however no insert installed on the extension plate.
