21 November 2023

## IICL – Refrigerated Container Technical Bulletin – RTB 010.

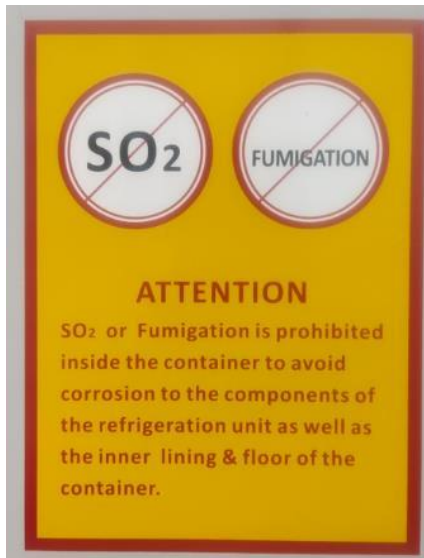
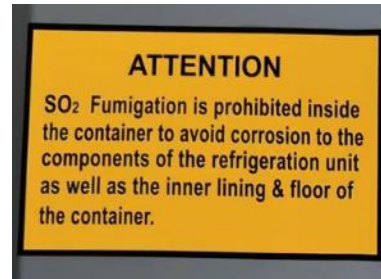
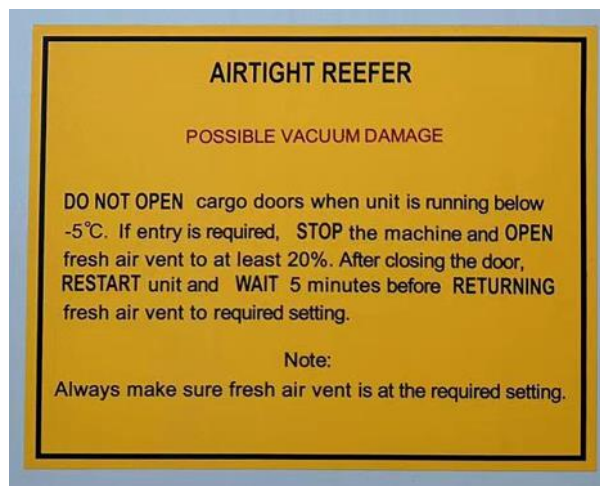
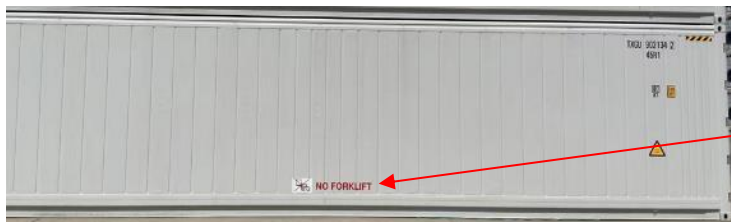
Here below are some examples (text and/or photos) of damages resulting from the misuse of refrigerated containers.

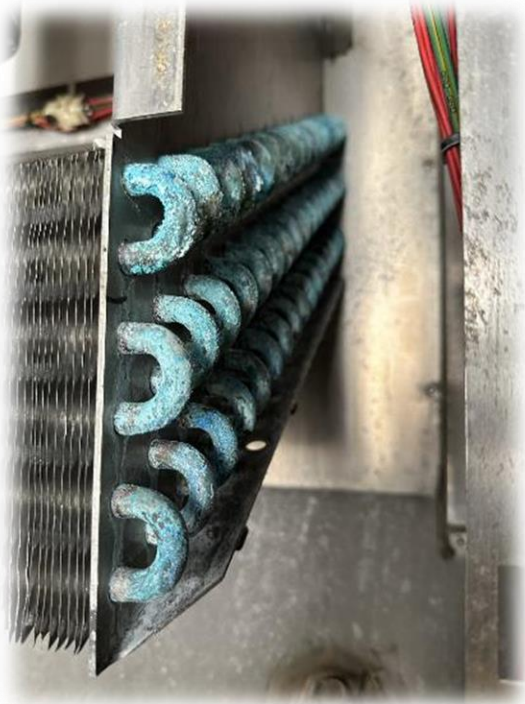
**Ammonia Contamination.**

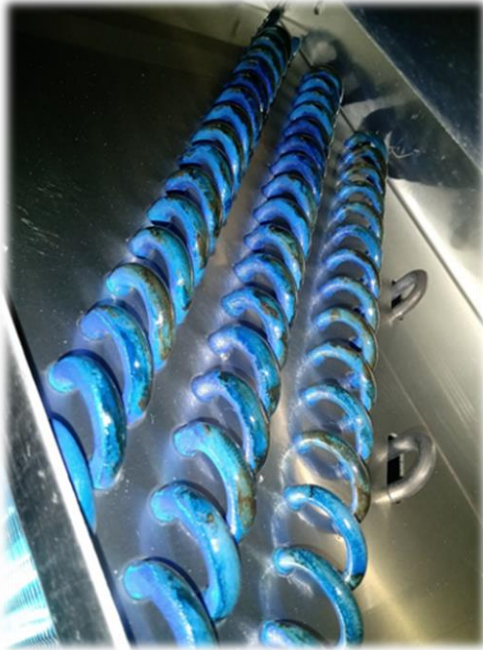
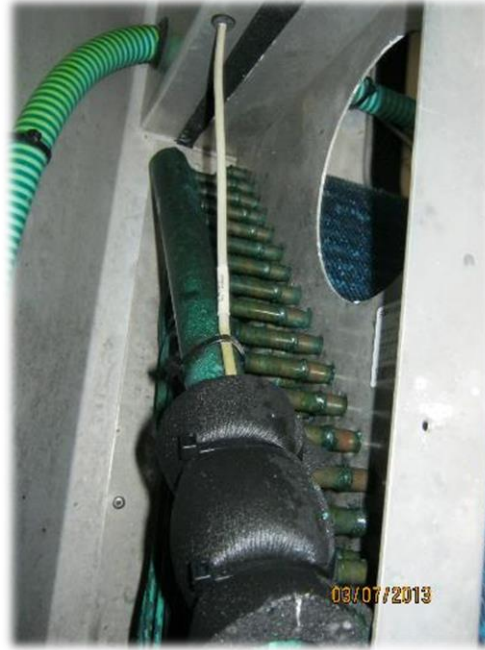
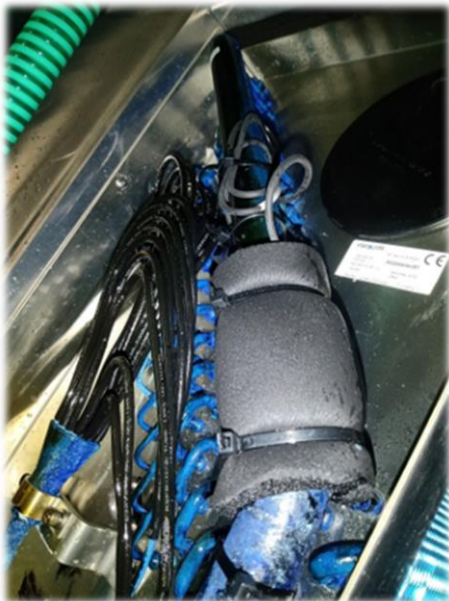
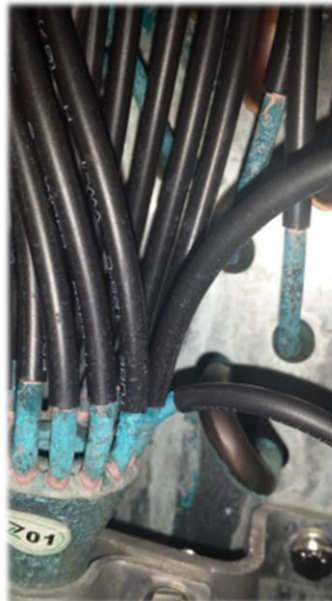
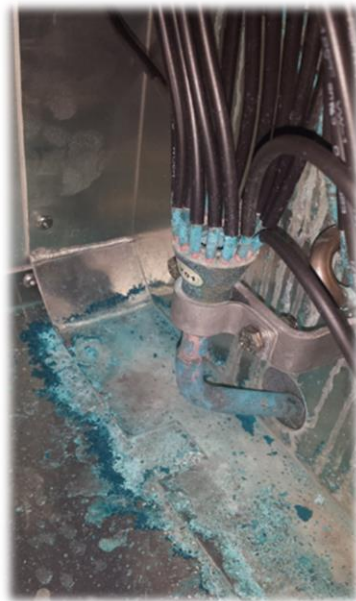
**Example of chemical gases contaminating copper machinery parts oxidizing the material and causing black stains.**

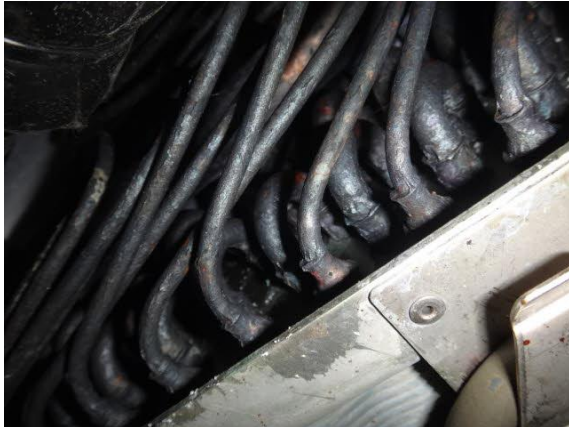
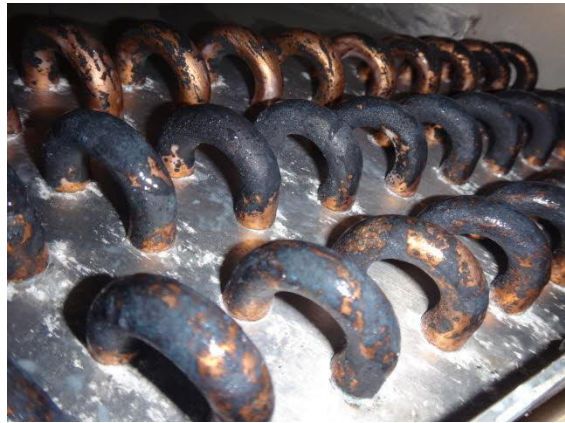
**Photos below show typical damage to interior panels (heavily scratched, bent and cut) due to loading of palletized cargoes built with dimensions for the interior of dry van containers instead of reduced internal width of refrigerated containers.**

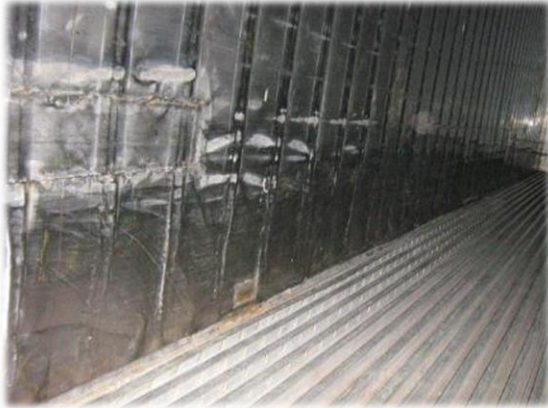
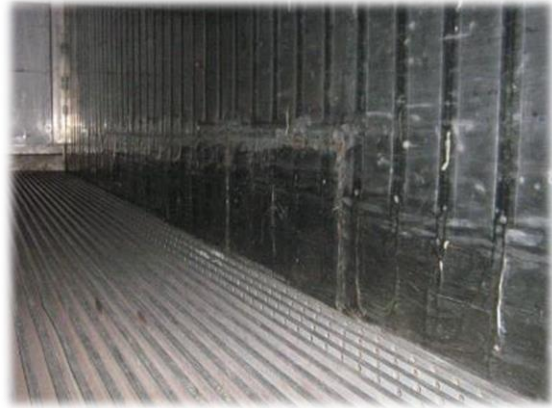
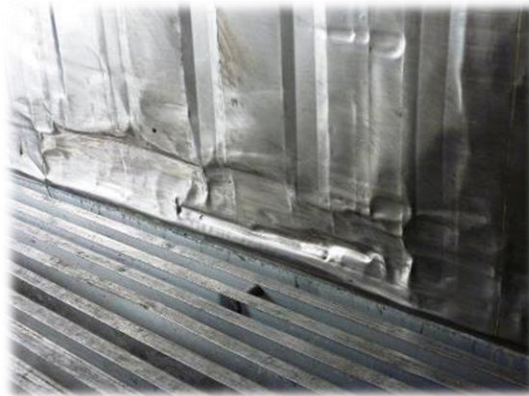
**Interior contamination caused by destructive and/or caustic substances.**

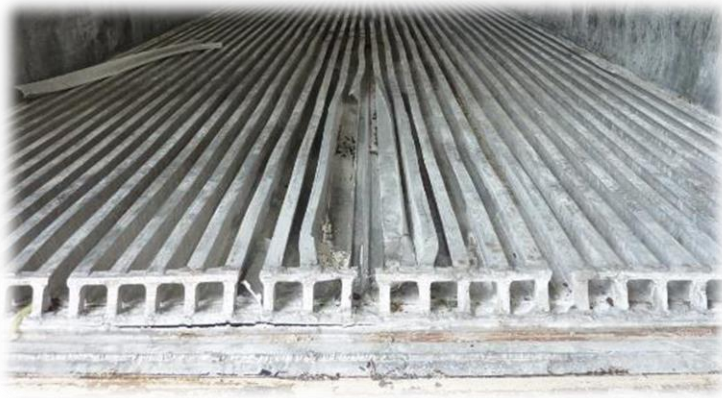
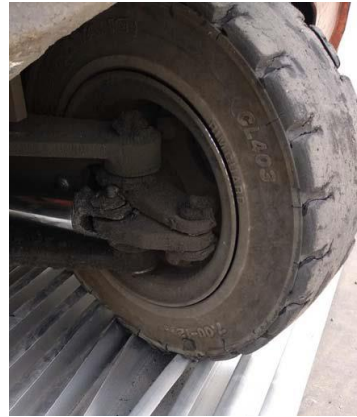
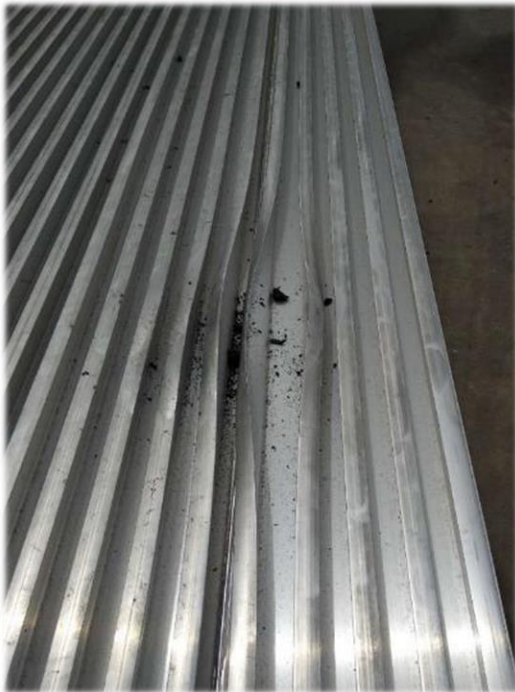
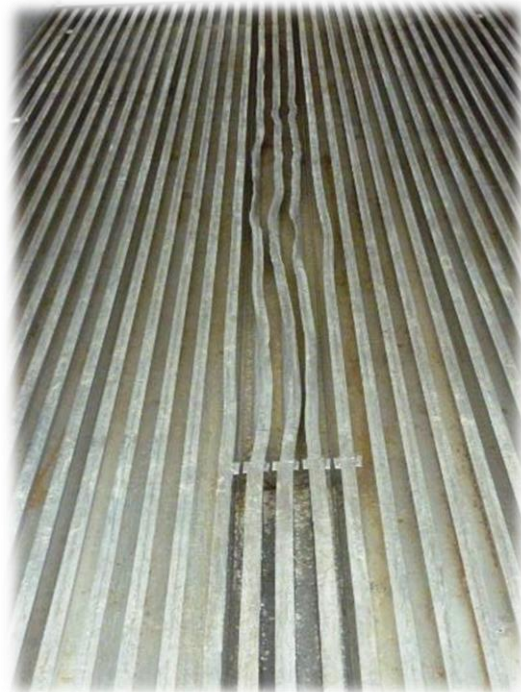
Examples of typical damage to evaporator coils caused by paper rolls pushed against bulkhead.

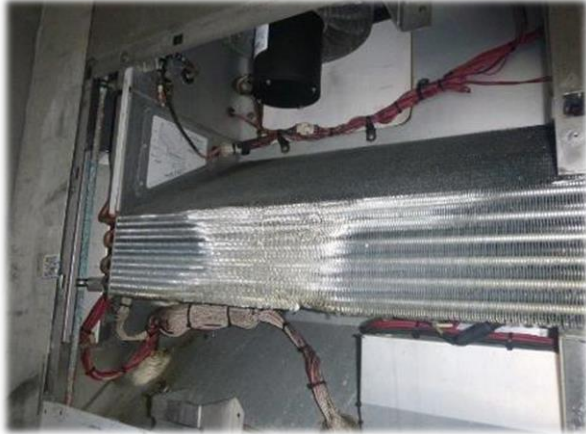
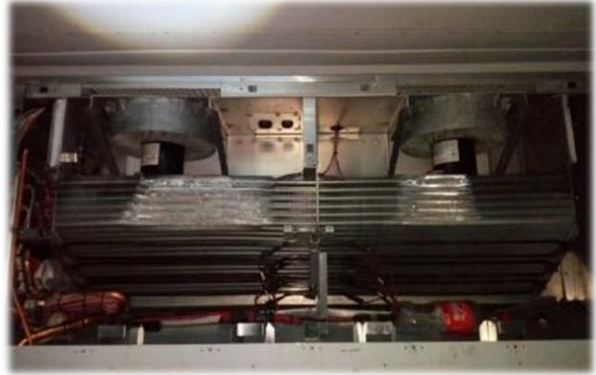
**Typical paper roll damage to evaporator coil.**

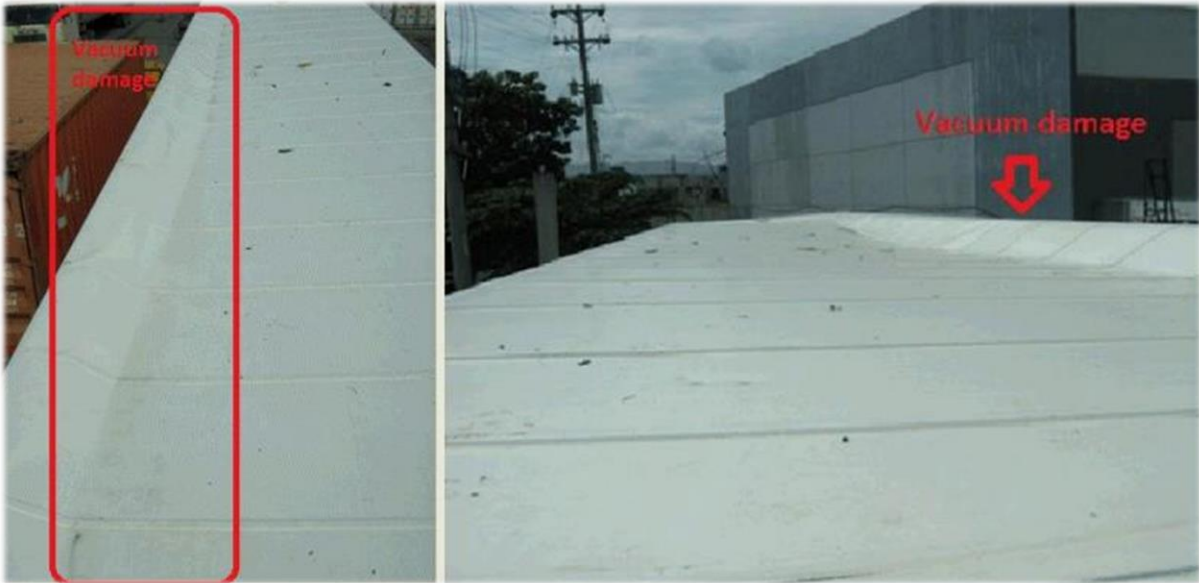
**Air fresh cover incorrectly sealed with tape.**

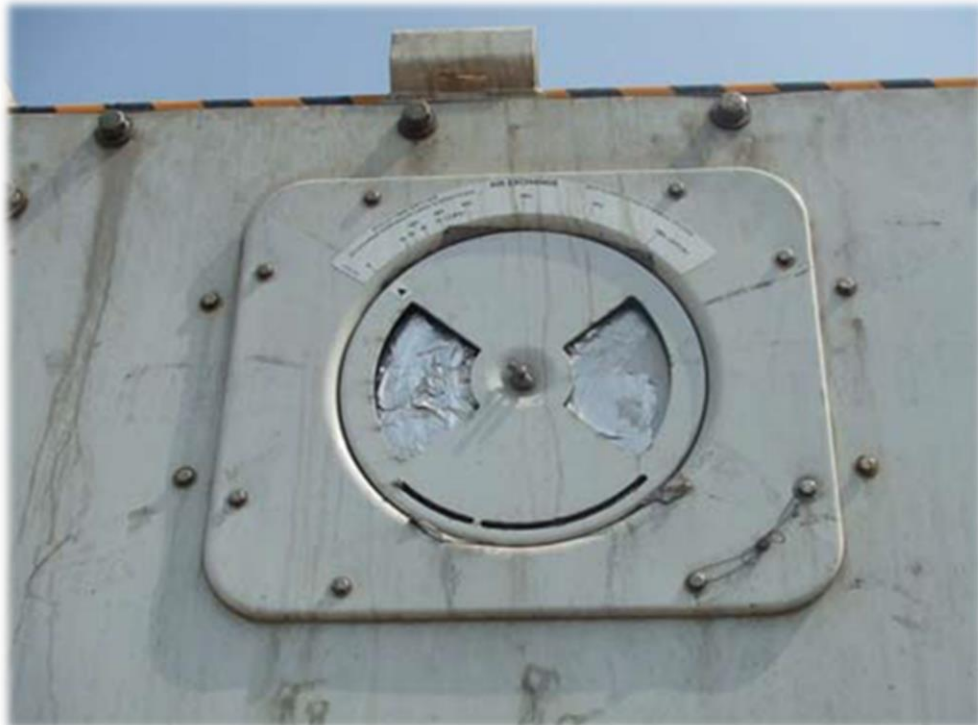
Damage caused by improper handling of 40ft refrigerated containers using forklifts. Usually, bottom rails show either inward or outward deformation close to the center of the container. The underside typically shows scratches, flat indentations, cracks, and cuts.
